*NIST Special Publication 862*

# 1994 Northridge Earthquake

## Performance of Structures, Lifelines, and Fire Protection Systems

*Diana Todd, Nicholas Carino, Riley M. Chung, H. S. Lew, Andrew W. Taylor,  
William D. Walton, James D. Cooper, and Roland Nimis*

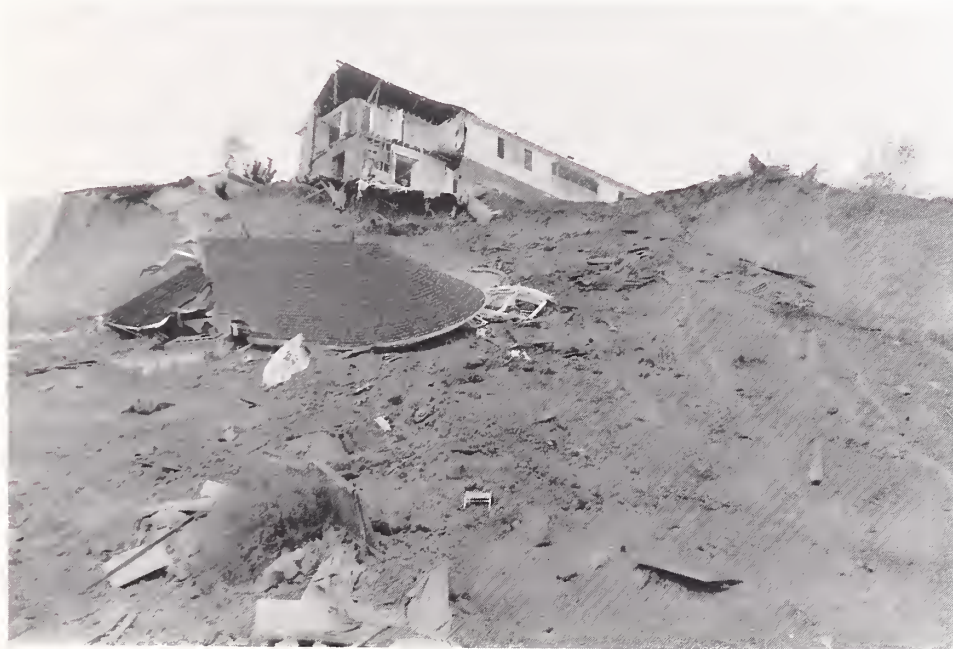
Landslides, rock slides and slope failures were the most visible geotechnical effect caused by the earthquake. Landslides along the Pacific coast in Santa Monica and Malibu damaged several buildings (fig. 2.8). Rockfalls in the Santa Monica, Santa Susana, and San Gabriel Mountains closed roads. Mulholland Drive in Sherman Oaks was temporarily closed because of the threat of slope failure.

Figure 2.8. A landslide along the Pacific Coast Highway north of Santa Monica undermined the foundation of a house at the crest of the slope, bringing a portion of the house down.

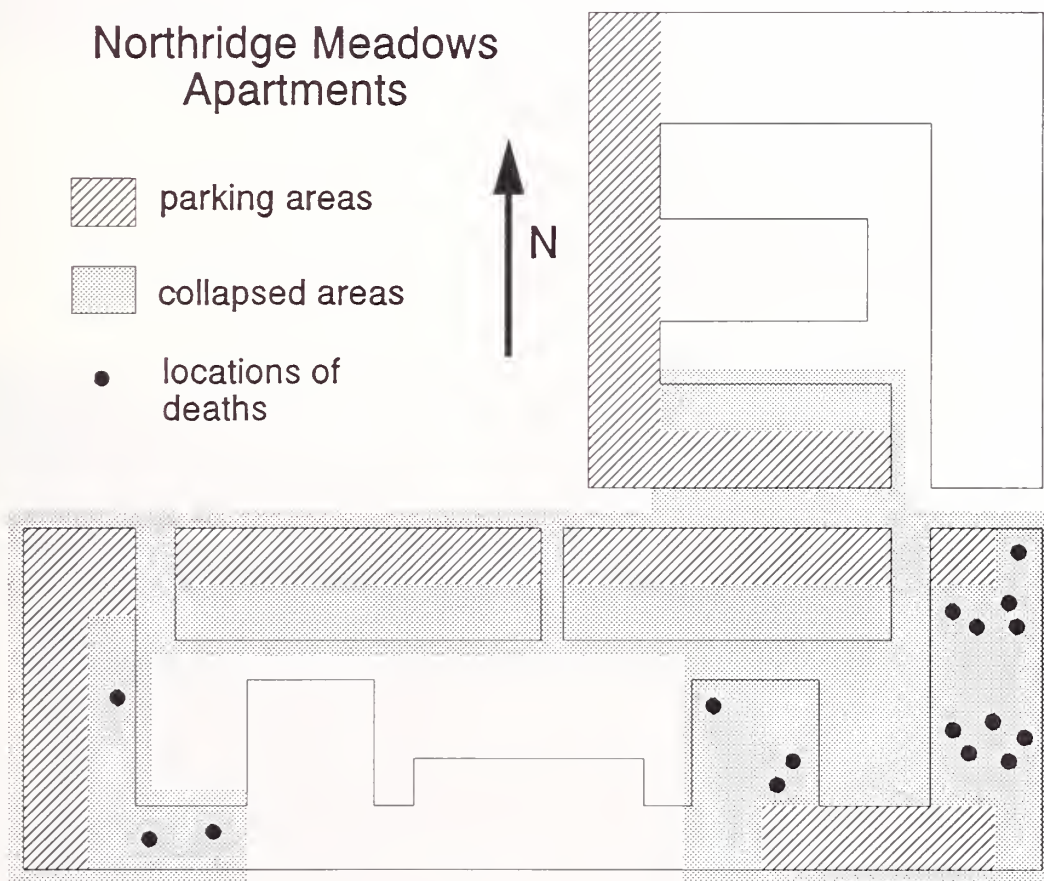
Collapses in a single apartment complex caused sixteen of the twenty-two deaths related to building failures [12]. The Northridge Meadows complex, constructed in 1972 (Los Angeles Times, January 19, 1994), consisted of several three-story wood-frame buildings, arrayed around courtyards on two sides of a mid-block alley. About half of the units had open spaces for parking on the street level. Typically these were around the perimeter of the complex. Most of the interior courtyard-facing units had living space at the ground level rather than parking. About half of the buildings in the complex collapsed. In all of the collapses, the first story gave way while the second and third stories remained largely intact. The 16 people killed were in first story apartments. All the buildings in the complex suffered some damage (figs. 3.3 and 3.4).

Figure 3.3. This plan of the Northridge Meadows apartment complex shows the distribution of parking and living spaces at the first level, and locations of deaths (source: Los Angeles Times, January 24, 1994). The shaded areas indicate the portions of the complex which collapsed.

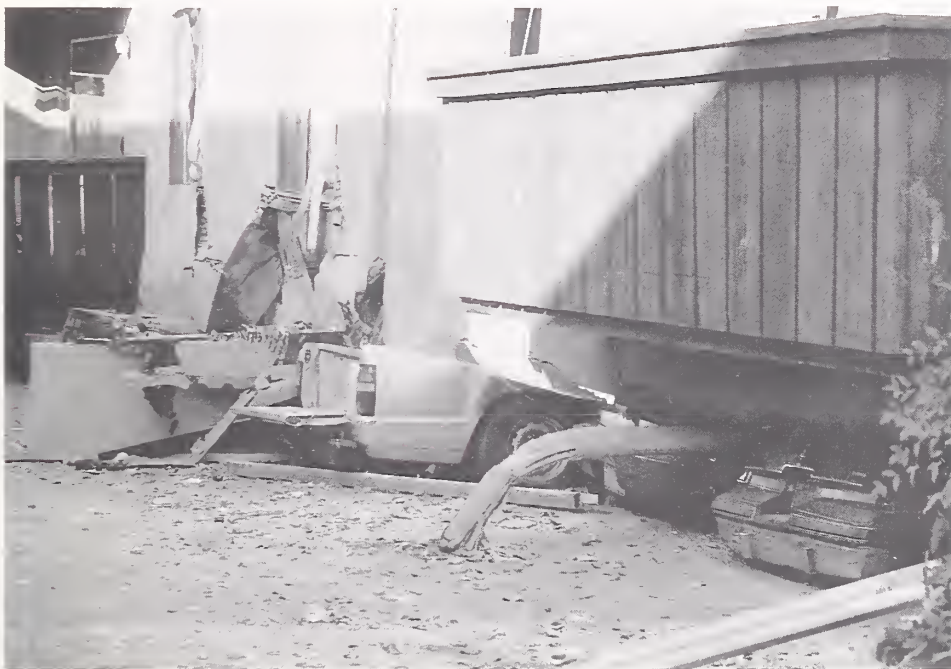
The upper stories of the collapsed buildings were displaced laterally and in some cases came to rest offset by as much as three meters from their original locations. The steel pipe columns, which hinged at their bases, apparently controlled the distance of the offset as they bent to the ground under the load of the building above (fig. 3.6). Collapses occurred in buildings aligned longitudinally east-west as well as those aligned north-south. At the southeast end of the complex, some building portions collapsed to the north, and other portions collapsed to the south, which indicates that no one extreme pulse of energy brought all the buildings down.

Figure 3.6. At Northridge Meadows, the first story steel pipe columns generally hinged near their bases but retained their length, controlling the displacement of the upper stories.

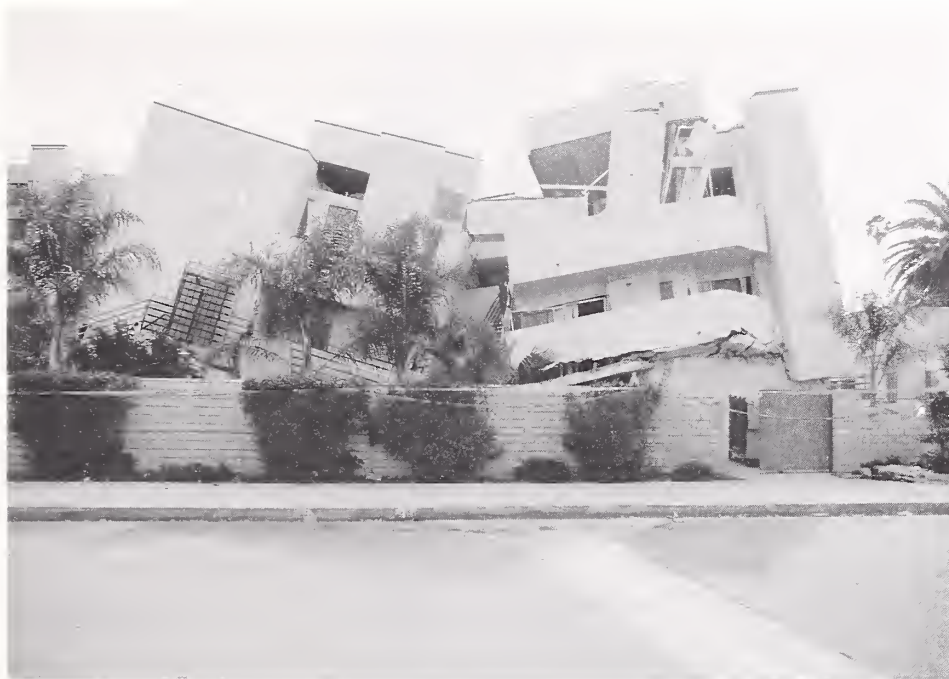
entire first story used for parking, located on Sherman Way in Sepulveda. In this building, the first story parking area was open only on the transverse ends. Concrete block walls formed the longitudinal walls at the first story and a row of concrete columns supported the mid-span of the flat plate concrete floor slab above. The two stories of living space over the parking level were wood-framed with a stucco facade. The entire line of mid-span concrete columns failed. The two halves of the upper stories settled in towards the middle (figs. 3.10 and 3.11), essentially destroying the structure.

Figure 3.10. The central row of concrete first-story columns in a three story apartment building on Sherman Way in Van Nuys collapsed, causing the wood-framed upper stories to settle inward.

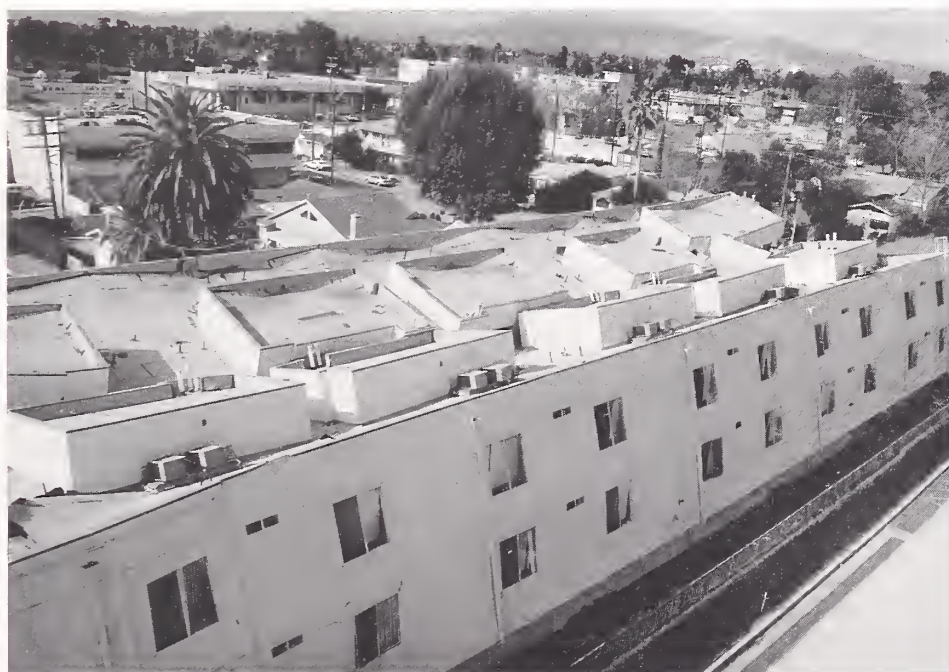
Figure 3.11. This overhead view of the partially-collapsed apartment building on Sherman Way shows the solid concrete masonry block perimeter walls along the longitudinal axis of the building. Access to the first story parking was limited to the transverse ends of the building. When the row of interior columns failed, both sides of the building settled in towards the middle.

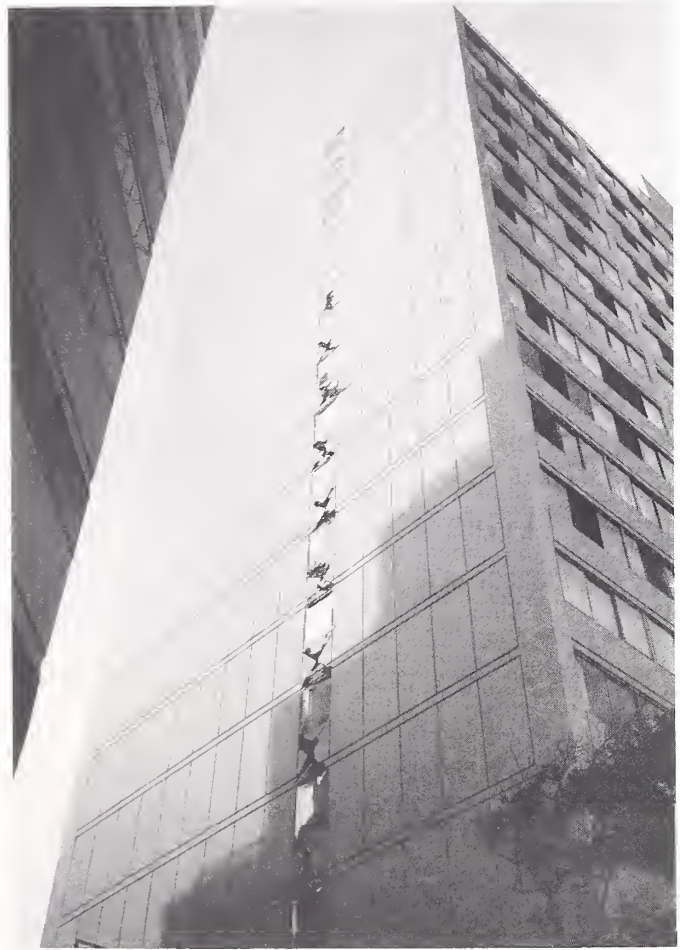
The transverse end walls are pierced by a single vertical row of window openings. The wall segments between the windows act as coupling beams linking the wall segments on either side. These coupling beams suffered serious diagonal cracking, increasing in severity from top to bottom of the building (fig. 3.12).

Figure 3.12. Champagne Towers apartment building in Santa Monica suffered a classic form of earthquake damage: shear failure of the coupling beams between linked shear walls at the transverse end of the building.

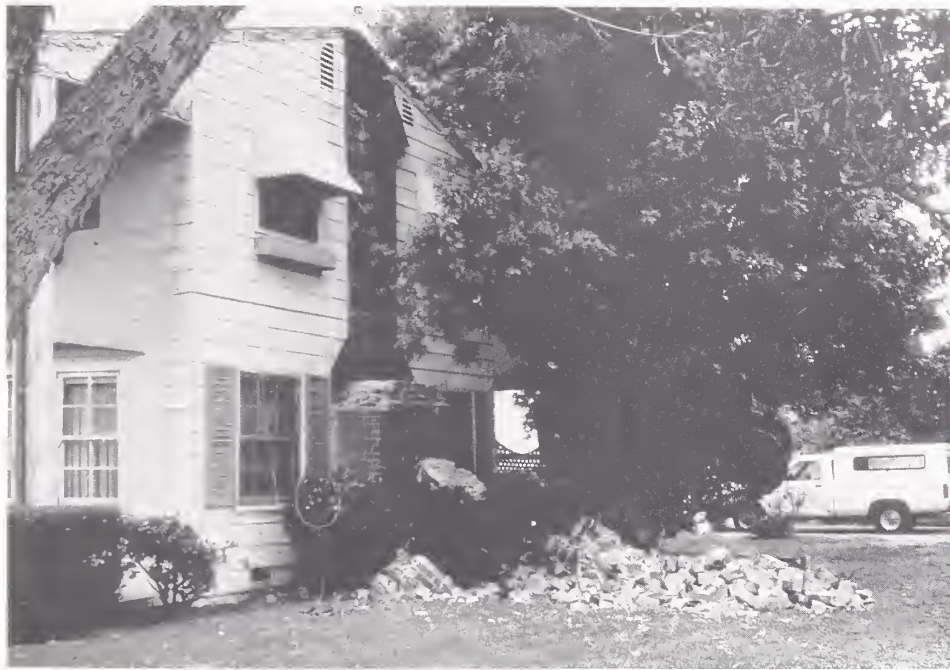
Figure 3.17. Failure of masonry chimneys was common.

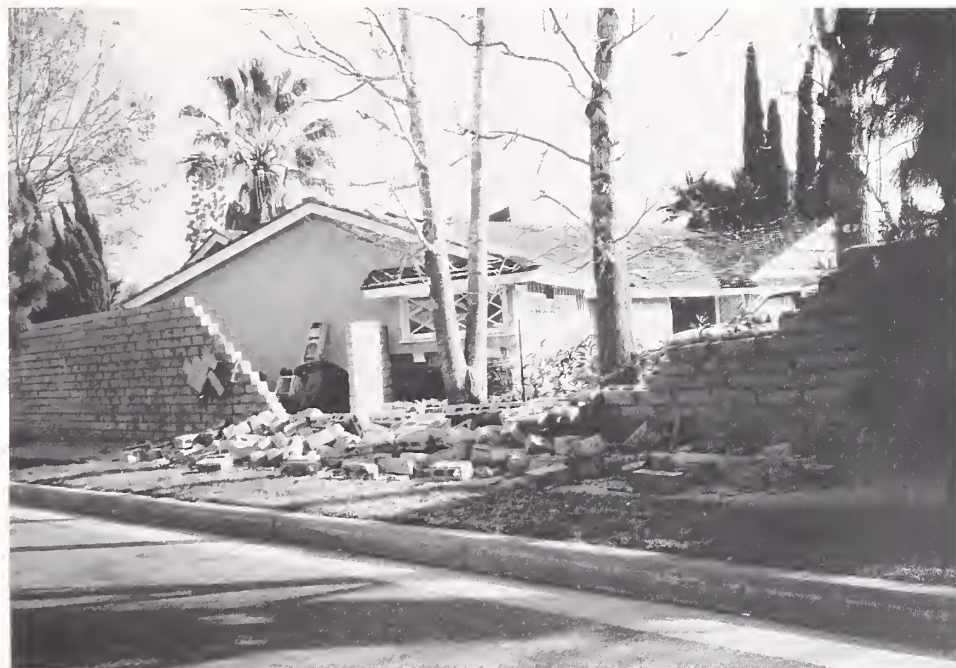
Figure 3.18. Damage to masonry privacy fences was ubiquitous. Many of these fences were tall enough to have been a serious threat to passersby when they failed. Luckily, due to the early morning hour of the quake, yards and sidewalks were essentially deserted.

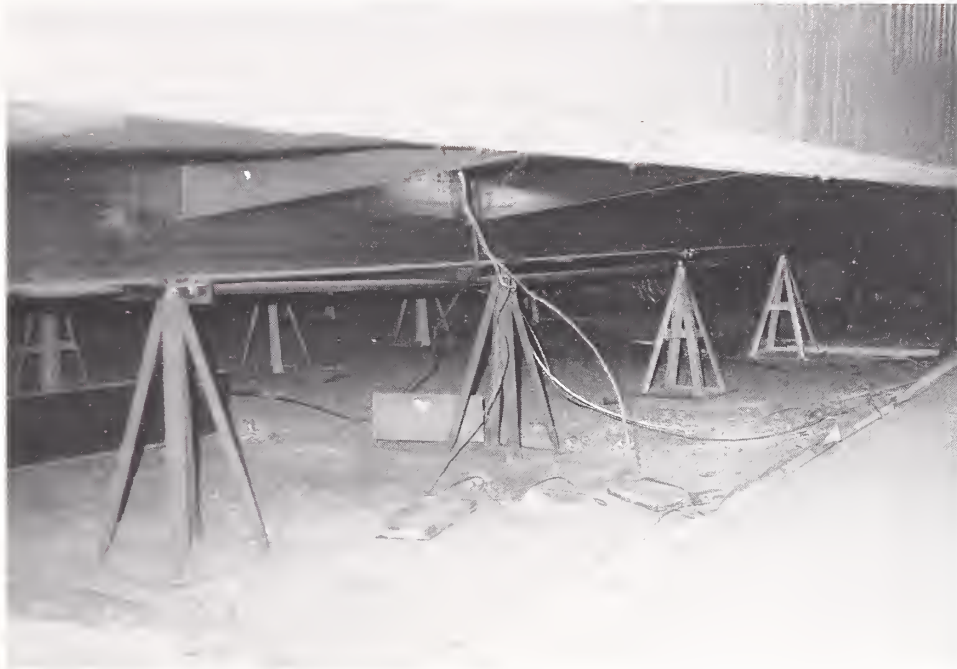
In some cases, the metal base supports were braced with small steel angle members. However, they were not adequately fastened to the supports and did not prevent the supports from rocking.

Figure 3.21. Another foundation system used for manufactured housing consists of supports constructed of small metal angles.

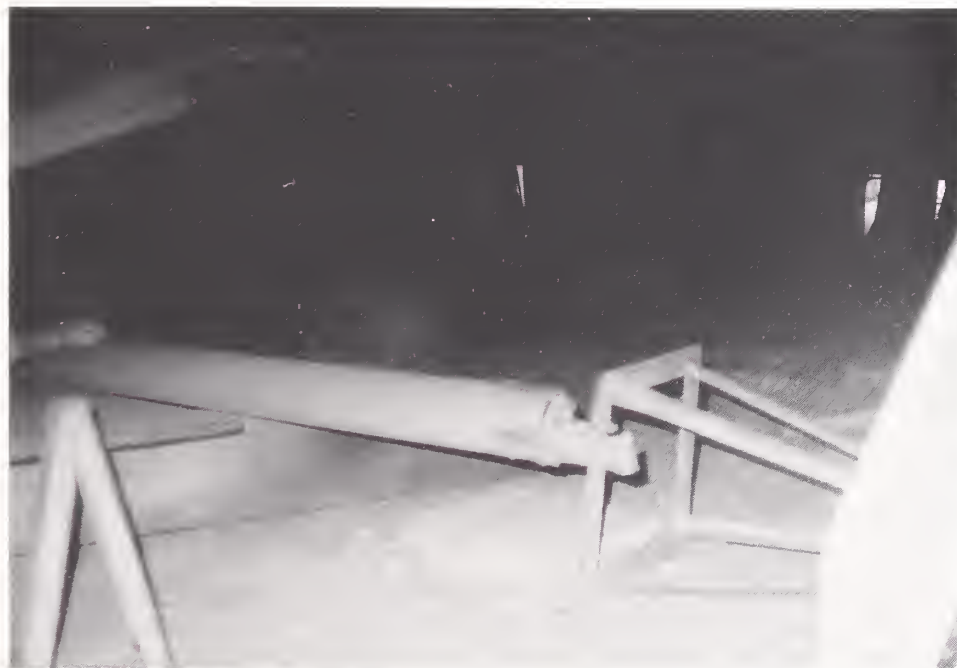
Figure 3.22. The metal supports under many homes tipped over, bringing down the houses above.

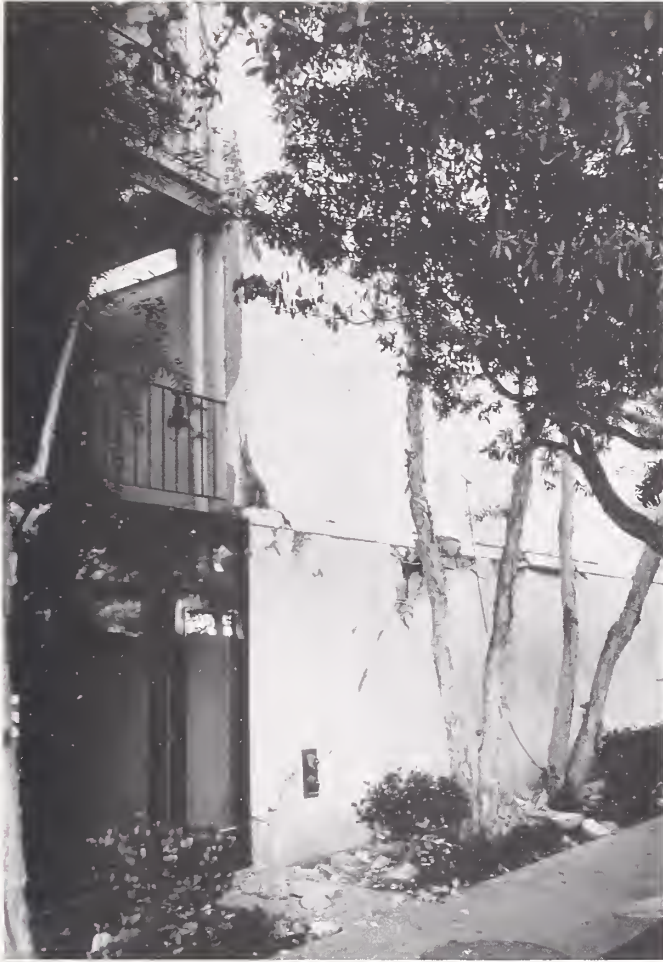
Figure 3.25. The concrete facade panels of the St. John's hospital parking garage had diagonal cracks and crushed toes.

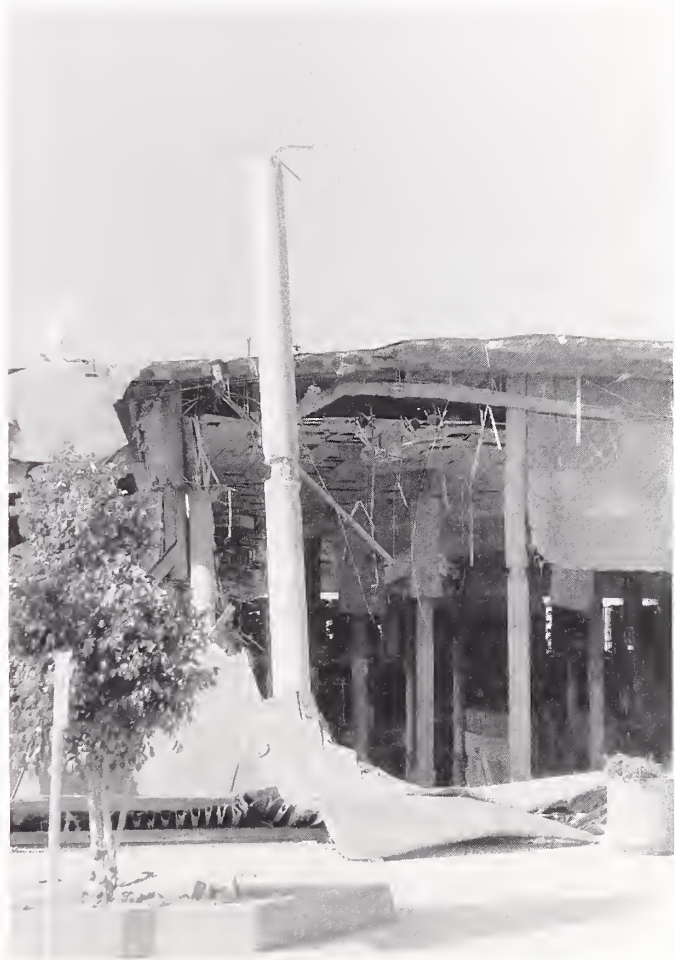
The collapse of large portions of the roof and floors of the three-story concrete Bullock's department store at the Northridge Fashion Center mall could have caused more deaths than any other single building failure in this earthquake. Many multi-story columns were left intact as the concrete slab floors and roof fell on top of each other to the basement, presumably due to punching shear failure of the slabs. The still-standing columns showed no evidence that slab reinforcement had been continuous through the columns (fig. 3.29). At the roof level, about a half meter of the column bar ends were bent over into the slab. The original building was extremely irregular, with a non-rectilinear vertical profile (fig. 3.30). Even in extremely regular buildings, this type of construction, which depends on the slab-column connection for moment-frame action, is vulnerable to damage from earthquake forces.

Figure 3.30. The Bullock's department store had an extremely irregular vertical geometry. At the northeast end it was shaped like a truncated pyramid.

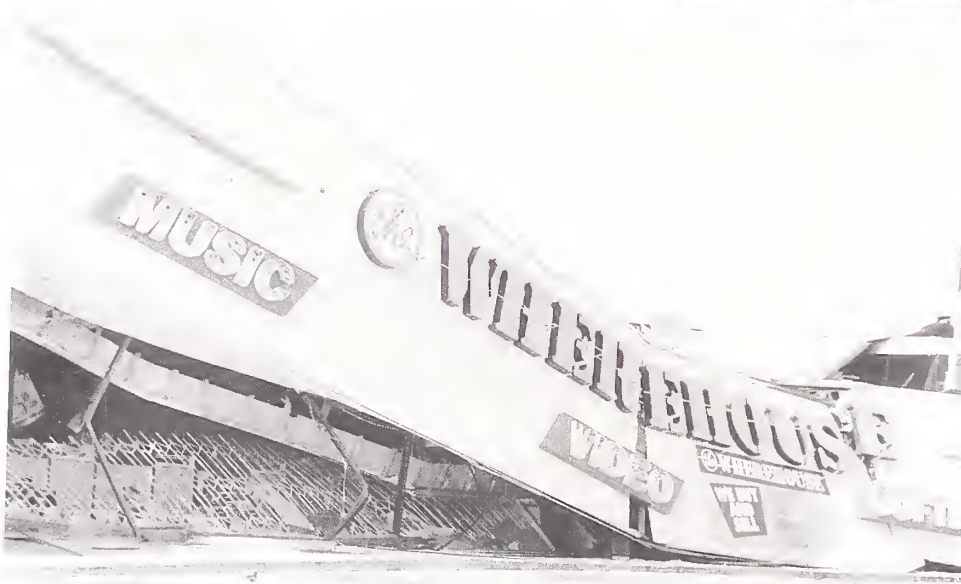
The area around the Northridge Fashion Center showed evidence of having been severely shaken. Significant damage of many types occurred. South of the Northridge Fashion Center, several single story retail structures were damaged; at least one, the Warehouse, collapsed (fig. 3.32).

Figure 3.32. Many commercial buildings were damaged in the blocks south of the Northridge Fashion Center. The single-story Warehouse collapsed completely.

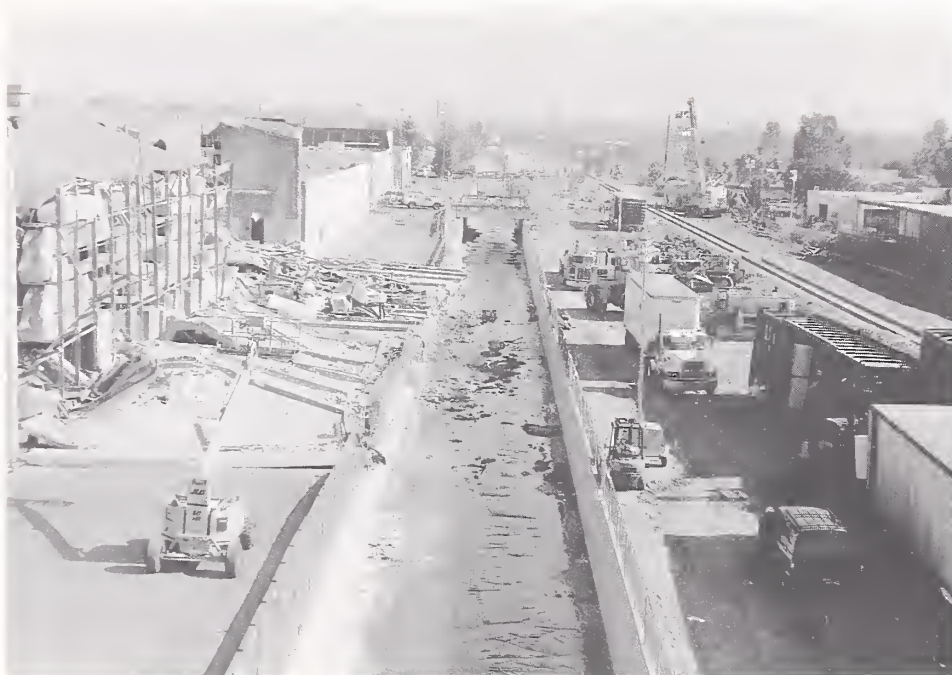
In the same area, the entire south wall of the concrete tilt-up Levitz furniture store fell away from the building to the south (fig. 3.33). In tilt-up construction, the concrete walls are formed and poured on the ground and, after the concrete cures, rotated into their final erect position. The remains of the damaged roof of the Levitz store, a plywood diaphragm, appeared to be supported by the top of the racks holding furniture.

Figure 3.33. The south wall of the concrete tilt-up Levitz furniture store/warehouse south of the Northridge Fashion Center fell away from the building into the alley and stream channel. The damaged roof was being supported by the racks of furniture. On the south side of the stream channel a freight train derailed during the earthquake. That clean-up effort was still underway three days after the quake.

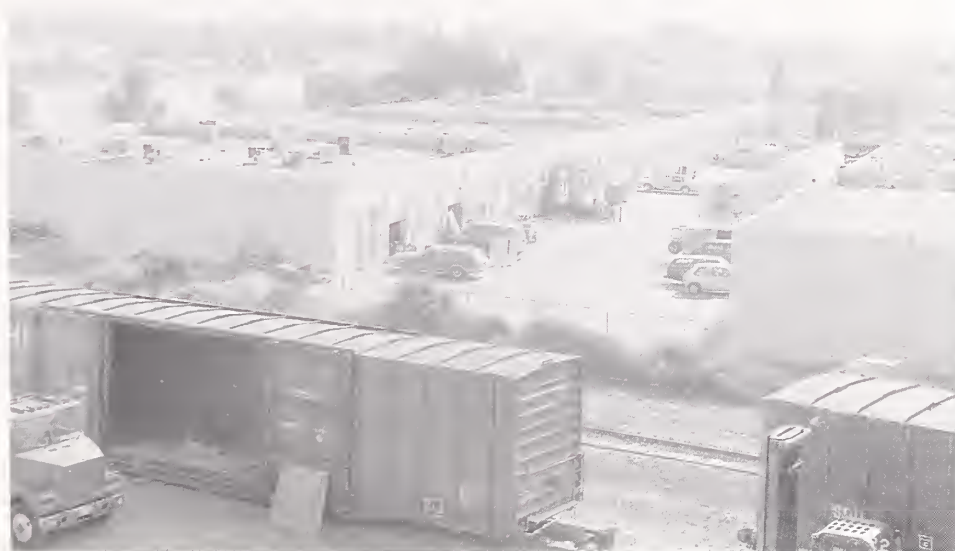
To the south of the railroad tracks and channelized stream, damage fell off dramatically. A tilt-up concrete building to the west showed no evidence of damage. No structural damage was visible in the modern single-story, reinforced masonry, garage-fronted commercial buildings (fig. 3.34), neither in the parapets nor the piers around the garage openings, doors, or windows. Clean-up activities in progress suggested that damage did occur to contents of these buildings.

Figure 3.34. The single-story modern masonry commercial buildings directly south of the damaged Levitz furniture store and train derailment were apparently undamaged. All parapets and piers between garage openings appeared intact.

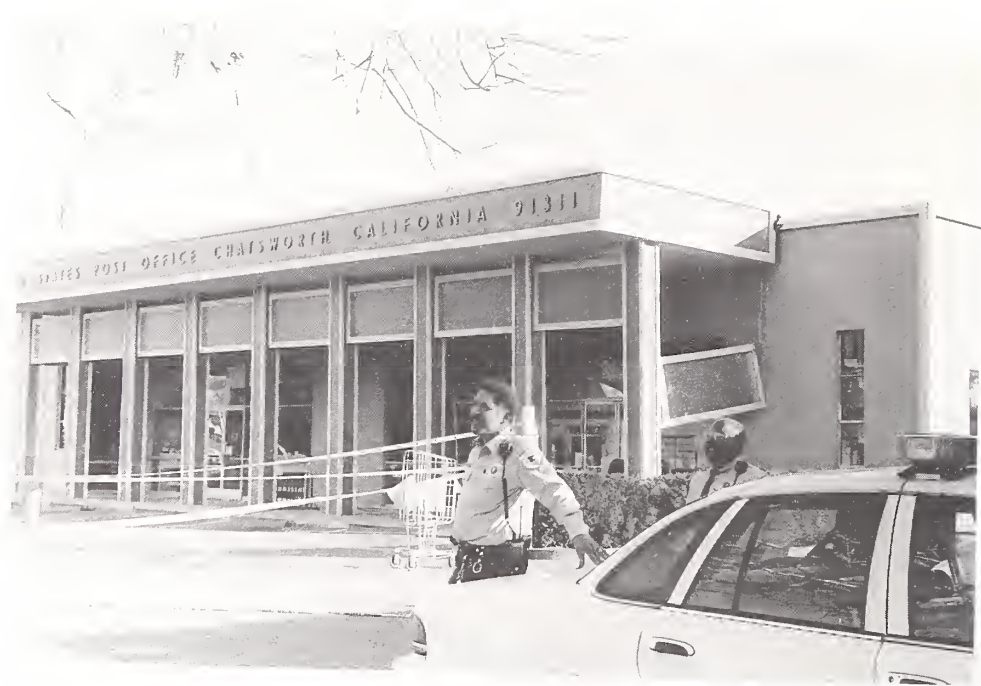
facade panel had become detached and interior ceiling panels had fallen (fig. 3.35). Mail was being collected in the parking lot.

Figure 3.35. The Chatsworth Post Office was closed due to damage. Mail was being collected in the parking lot.

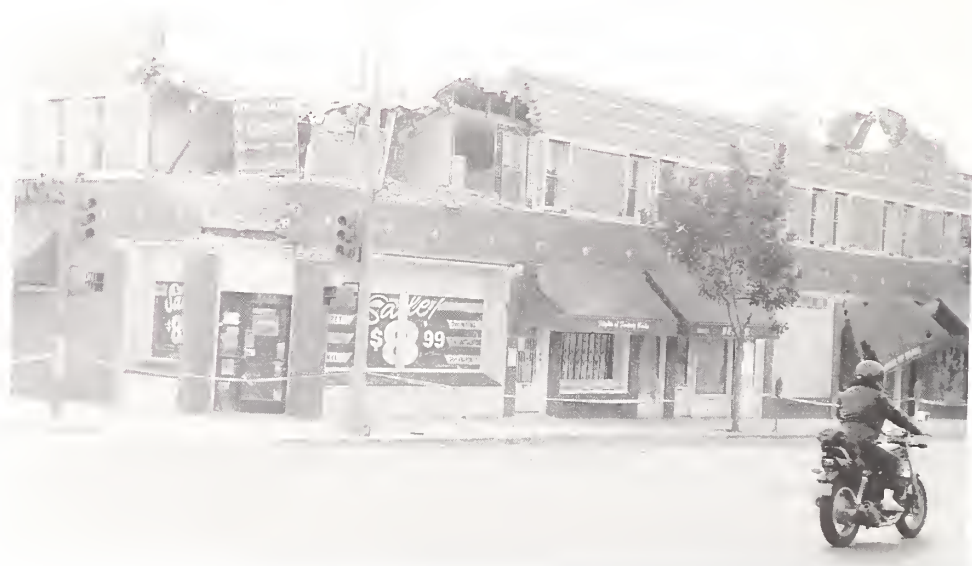
Figure 3.36. Damage to unreinforced masonry buildings, even those that had been rehabilitated, was common. Upper stories and corners were particularly vulnerable to damage. The rows of light-colored diamonds on the face of this building are the end plates of through-bolts used to connect the wall to the floor joists, a typical rehabilitation technique. The remains of parapet braces can be seen on the roof.

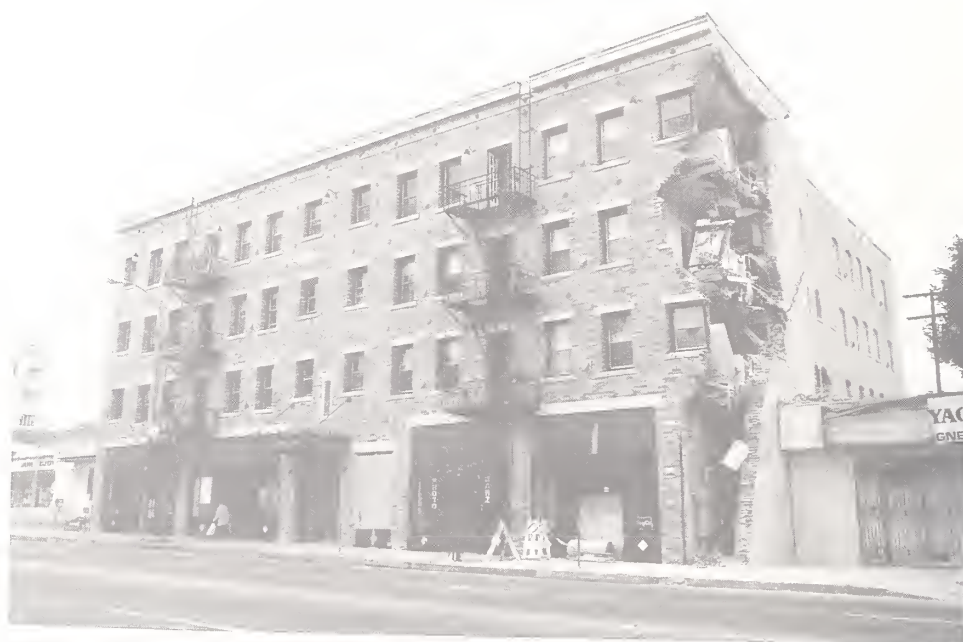
Figure 3.37. The corner of this rehabilitated unreinforced masonry apartment building in East Hollywood crumbled on all four stories.

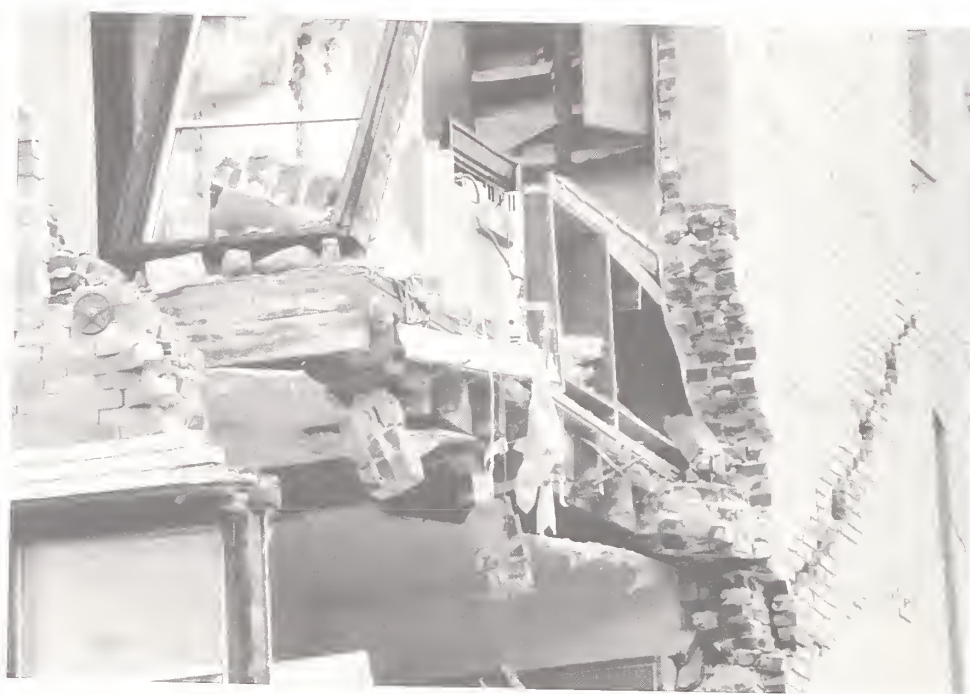
Figure 3.38. A close-up view of the third-story floor diaphragm of the building picture above shows (lower right) a rehabilitation bolt still holding a few bricks to the floor joists, after all the walls on three out of four sides of the bolts had disintegrated.

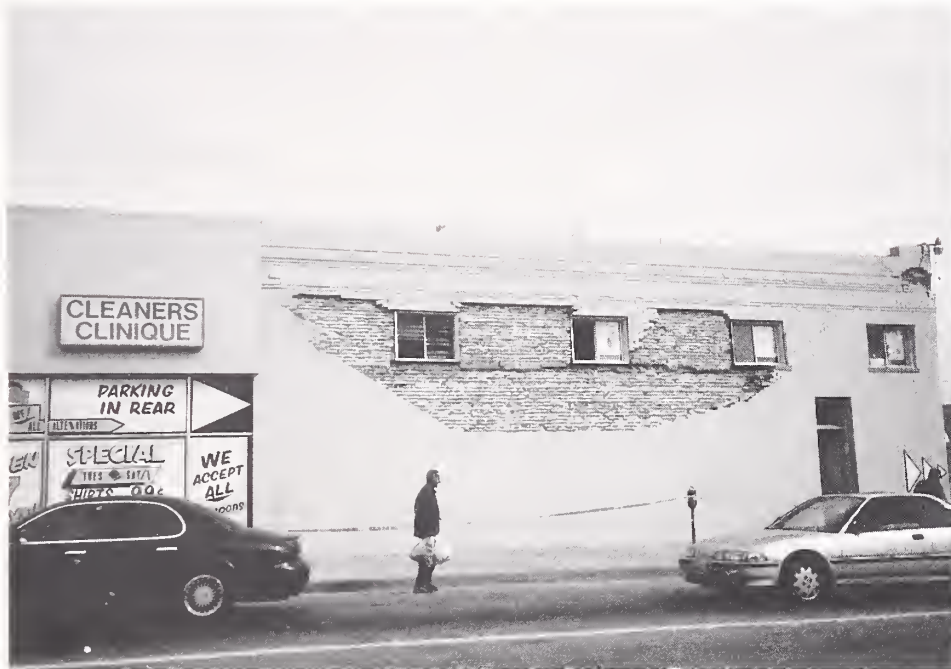
Figure 3.39. Only the exterior wythe of brick peeled off of this rehabilitated unreinforced masonry building in Santa Monica.

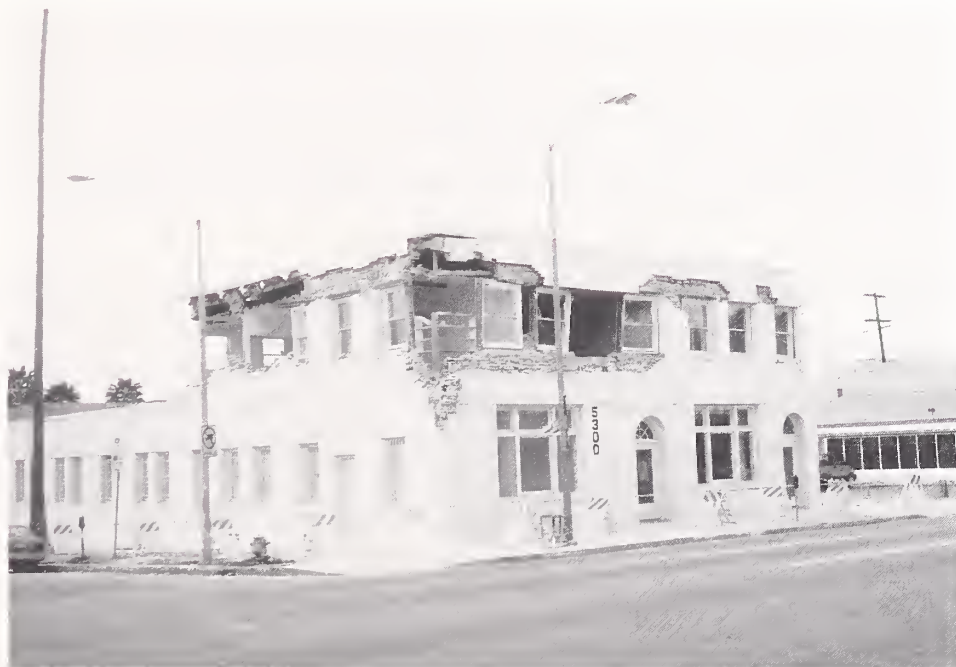
Figure 3.40. In other rehabilitated unreinforced masonry buildings, such as this two story structure in Hollywood, entire wall thicknesses were lost between rows of through-bolts.

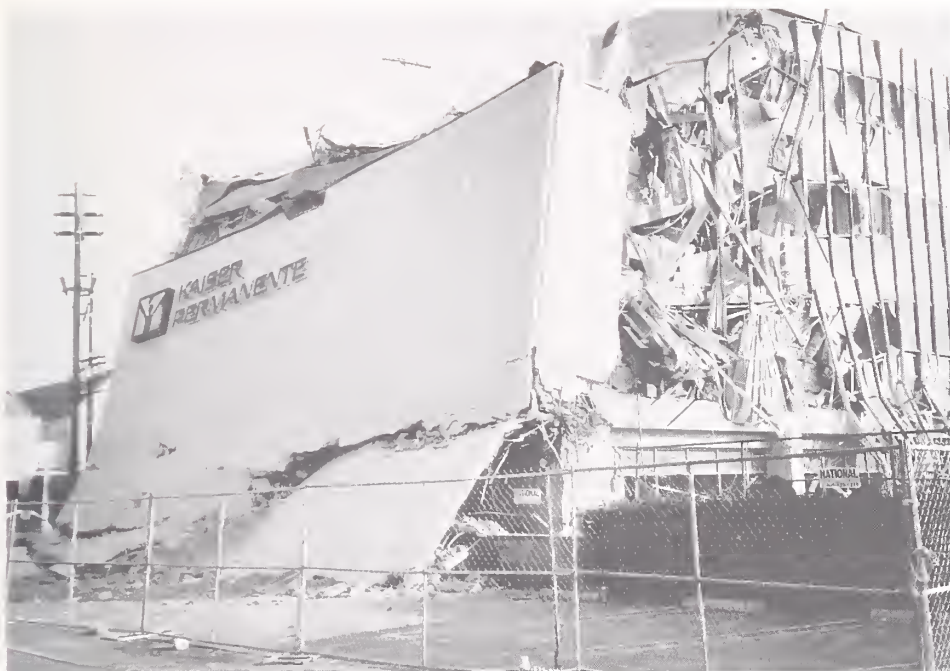
Figure 3.43.  
Damage at the  
north end of the  
building was similar  
to damage at the  
south.

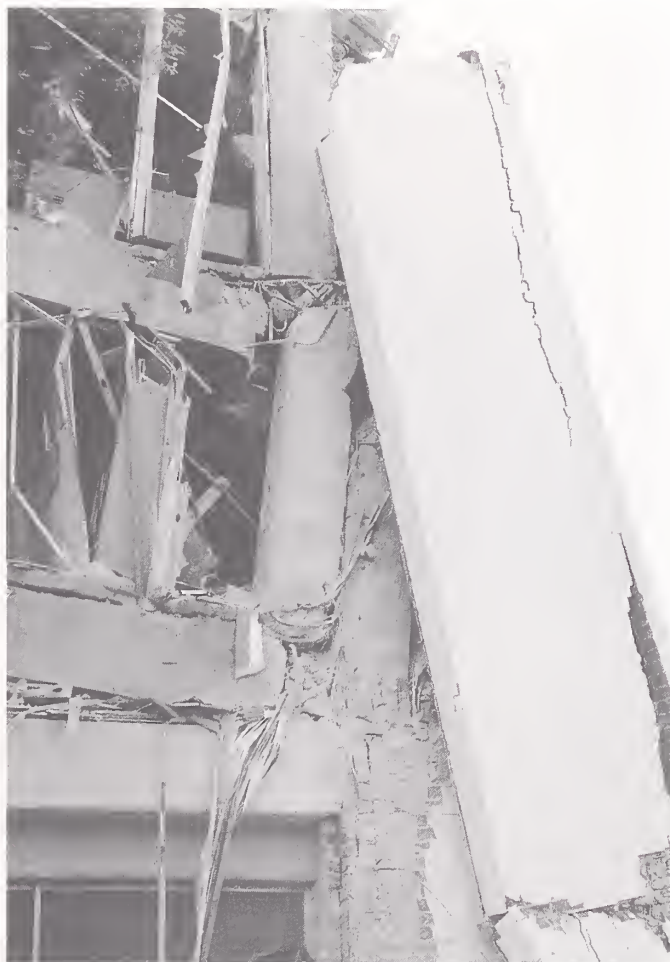
The bare frame exposed by the damage suggests that the buildings had a strong-beam/weak-column configuration (fig. 3.44). The damage appears to have initiated at the joints. At the damaged ends, the beams and columns remained essentially intact, but the joints disintegrated.

Figure 3.44. The exposed concrete  
frame of the Kaiser Permanente  
building, revealing deep beams,  
suggests that the building had a strong-  
beam, weak-column configuration.  
Except for the second story columns,  
the columns and beams remained intact  
while the joints disintegrated.

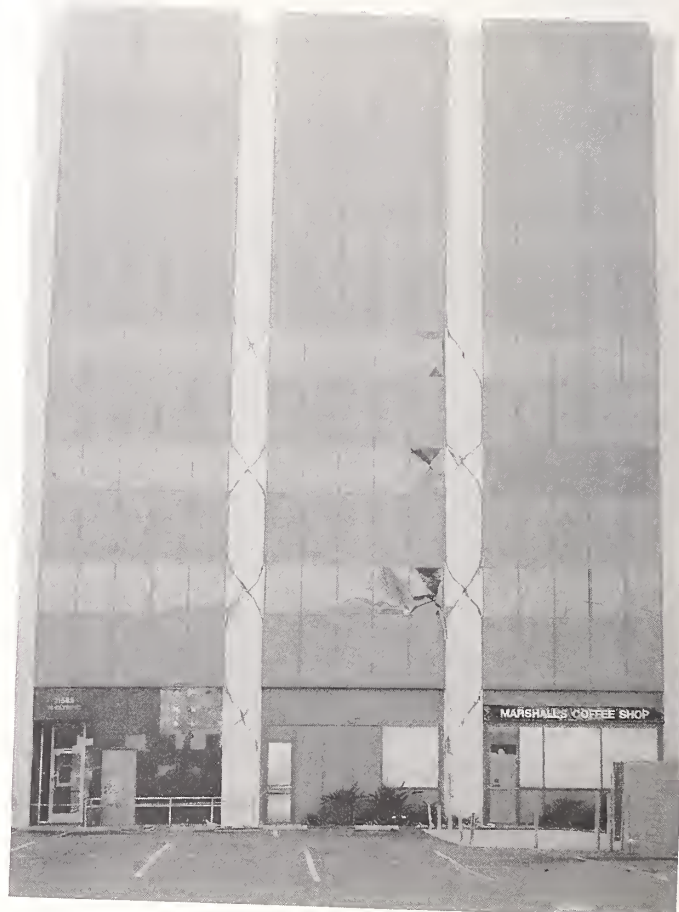
The L-shaped concrete frame Barrington Building in West Los Angeles also had damage concentrated in the second story columns (fig. 3.45). In this building, the horizontal architectural panels stiffened the lower half of the columns at each story, creating a short-column effect. The effectively shortened columns failed in shear between the windows, creating a pattern of X-cracking in the columns that diminished in severity towards the top (fig. 3.46). At the second story, the cracking was severe enough to cause a loss of vertical-load-carrying capacity; the bulging window frames indicate about a 50 to 100 mm reduction in height (fig. 3.47). The building was demolished within a few days of the quake.

Figure 3.46. The stiff infill panels of the Barrington Building effectively shortened the concrete columns, forcing all the displacement into the column sections bounded by windows. Diagonal X-cracking decreased in severity towards the top of the building.

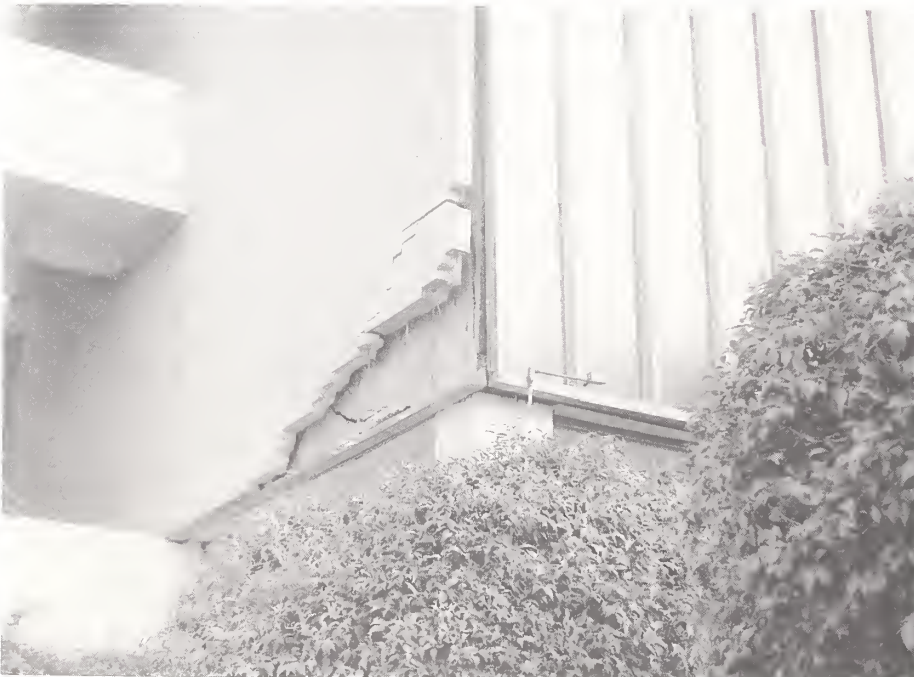
Figure 3.50. The similar west wall of was damaged, but did not peel away from the structure. This close up of the interface between the first and second stories shows that the masonry facade is supported on a steel angle. At the west end of the building, the facade was crushed at the toe where it is supported by the angle.

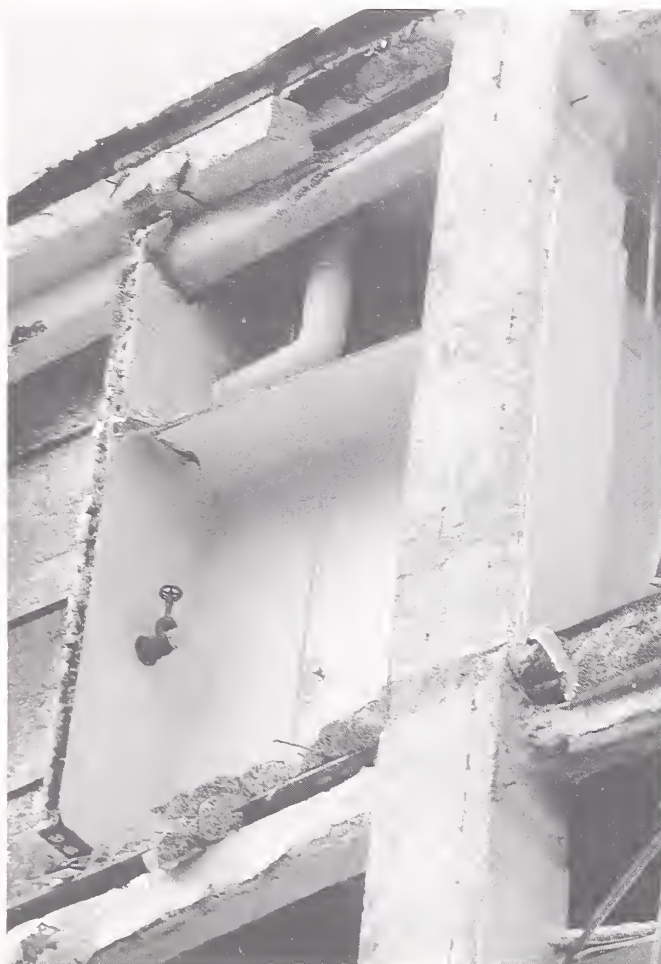
Figure 3.51. The exposed structure of the Sherman Way office building shows remains (at the floor level and the column) of the minimal ties that anchored the masonry facade.

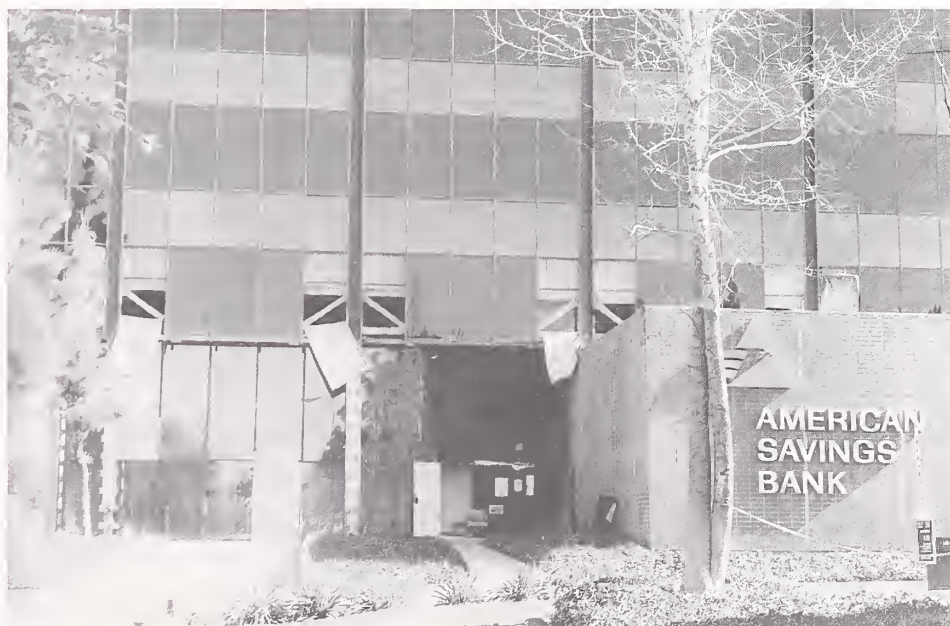
A steel-frame office building on the west side of Topanga Canyon Boulevard in Canoga Park, housing the American Savings Bank, experienced significant movement in its first story columns, apparently swaying in a north-south direction during the quake. It did not return to its original position, but suffered a permanent offset to the north (fig. 3.52). A nearly identical building on the same site, oriented at right angles to the first, had only minor damage to glass at the first

Figure 3.52. The first-story columns of the steel-framed building housing the American Savings Bank on Topanga Canyon Road in Canoga Park flexed during the quake and ended up slightly displaced from their original positions.

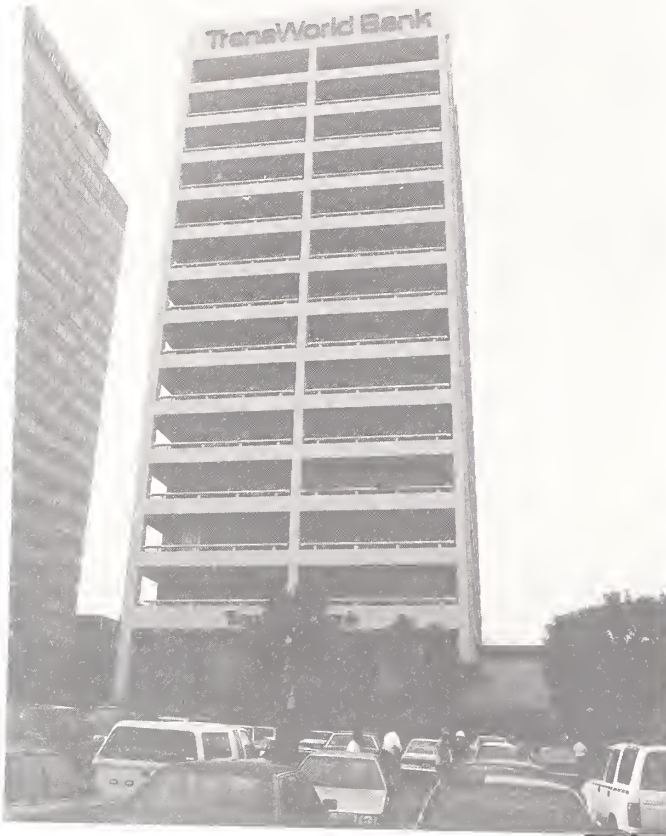
Figure 3.53. The Trans World Bank building, in Sherman Oaks, was damaged in both the 1971 San Fernando and 1994 Northridge earthquakes.

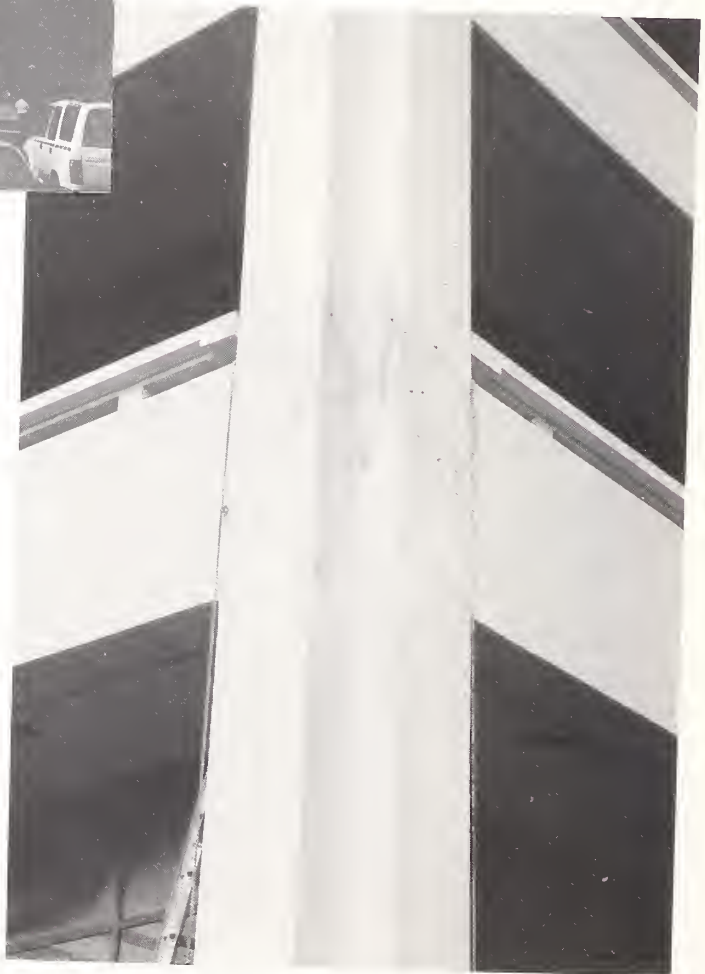
Figure 3.54. The cracked beam-column joints between the first and second stories of the Trans World Bank building were repaired using epoxy injection.

The business district along Ventura Boulevard in Sherman Oaks was another area with significant numbers of badly damaged buildings. The 13-story Trans World Bank Building is located at 15233 Ventura Boulevard (fig. 3.53). There is a two-level underground garage below the building and a mechanical penthouse on the roof. This reinforced concrete frame building was designed under the 1964 Los Angeles City code. Structural damage was in the first-story columns, primarily at the second-floor beam-column joints. Identical failures occurred during the 1971 San Fernando earthquake. The damaged joints were repaired with epoxy shortly after the 1994 earthquake (fig. 3.54).

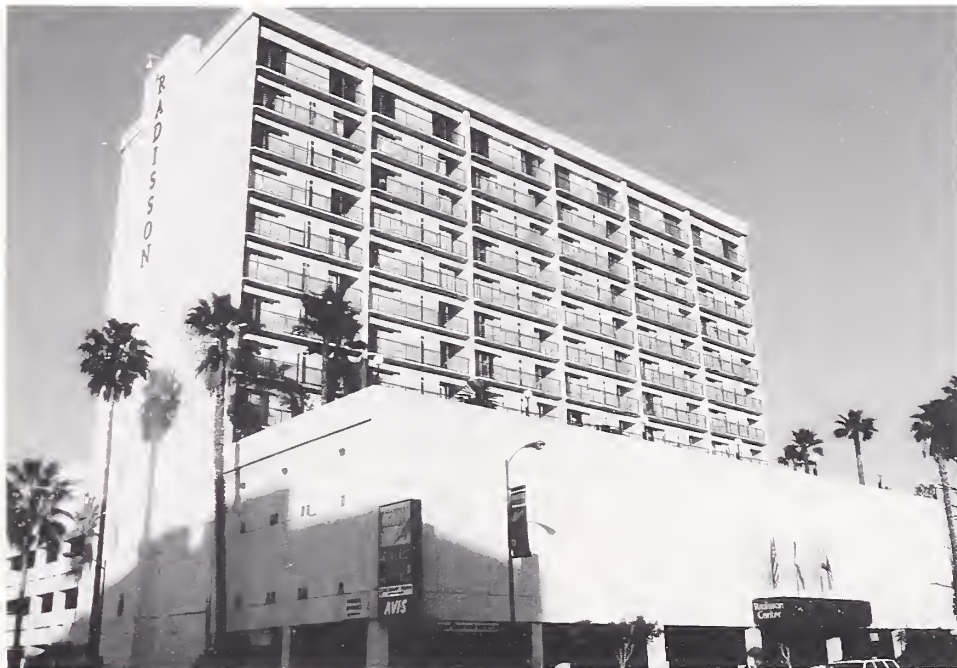
The Radisson Valley Center Hotel is located at 15433 Ventura Boulevard in Sherman Oaks (fig. 3.55). This 13-story concrete structure sustained serious damage to columns located at the first and fifth stories. Exterior columns which support the three-story appendage at the front of the hotel were also damaged (fig. 3.56)

Figure 3.55. The concrete Radisson Valley Center Hotel in Sherman Oaks had serious damage to the columns at the first and fifth stories.
